Lisa repair

written by Sergio Gervasini for ESOCOP
The European Society for Computer Preservation
<https://www.esocop.org/>

Apple Lisa repair

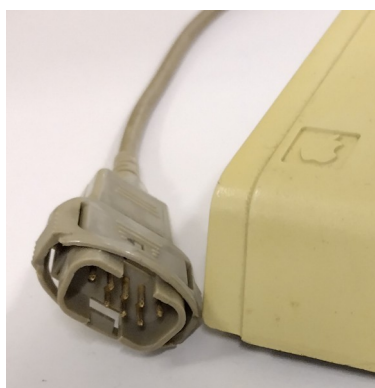
Also note the mouse connector, in the first models it allowed the insertion of only its custom mouse, while later a more standard DE-9 was adopted which also allows the use of MacIntosh mouse.

Lisa 1 mouse connector

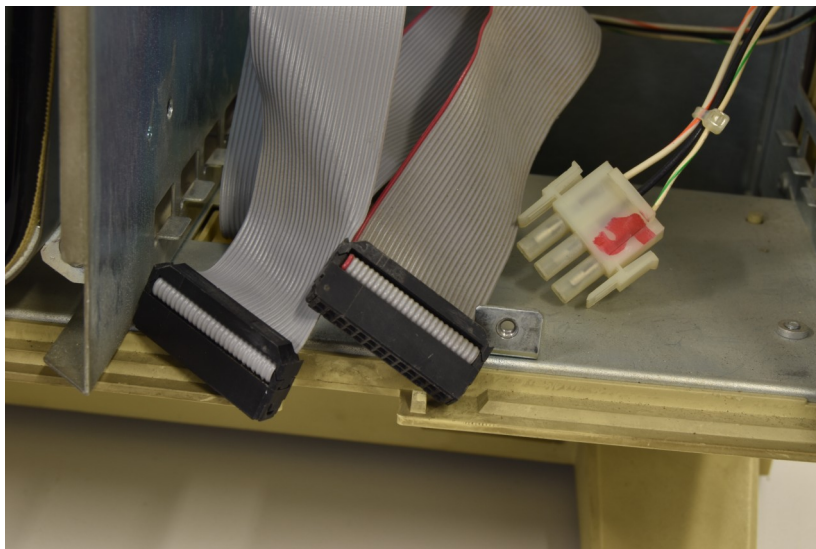
Another difference can be seen internally, in the area where the Twiggys are housed in the Lisa 1 and where the 3"1/2 floppy disk is located in the later versions. In the Lisa 1 there are 2 flat cables of equal width, where the Twiggys are connected, plus a power connector.

Detail of the connection of the flat cables on the motherboard connector in a Lisa 1

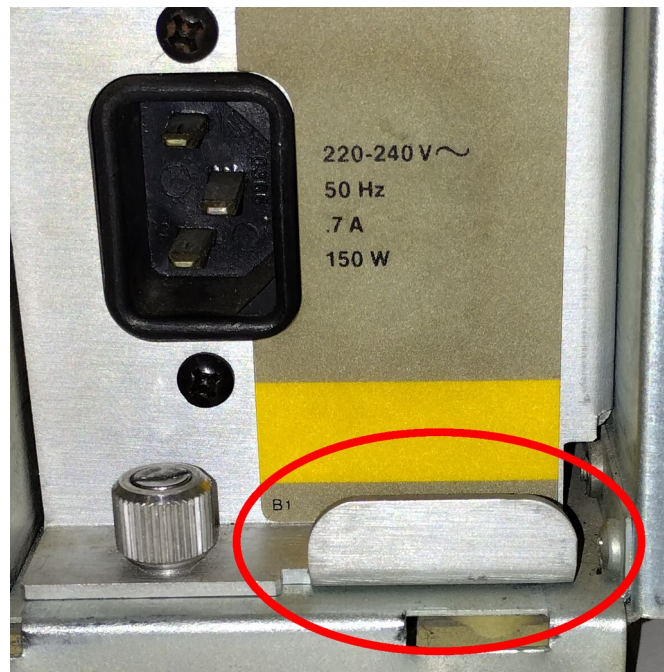
They are easily removed from the chassis, just unscrew the knurled screw at the bottom and once free, pull firmly on the flap next to the screw, possibly levering it with a screwdriver (see photo).

Do not use two potentiometers at the top to help yourself, they are very delicate and could break.

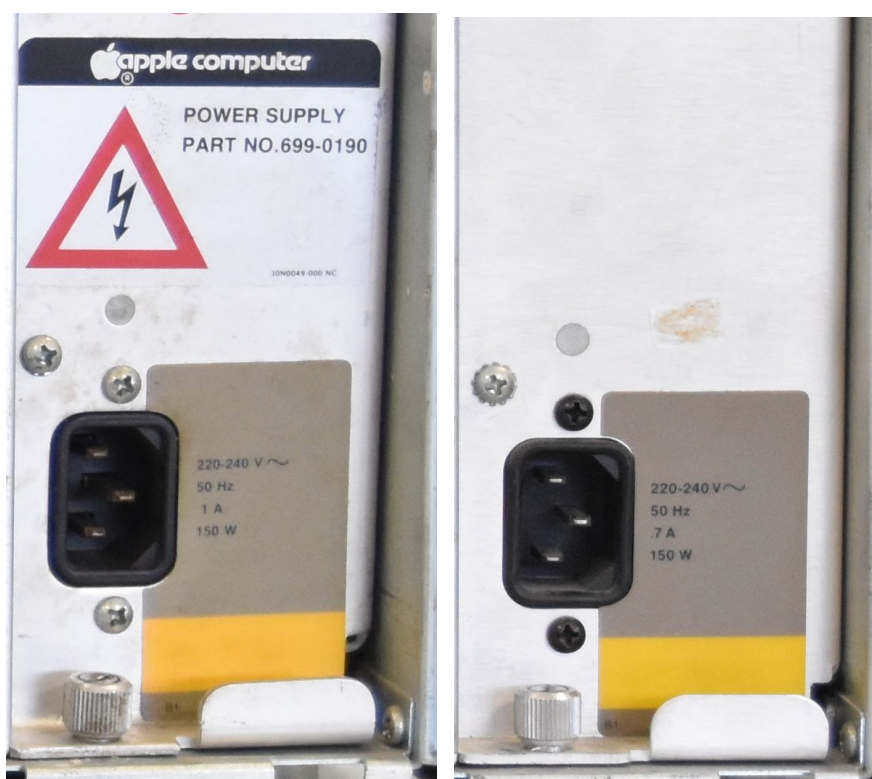
In our case we are dealing with machines suitable for European voltages, so the names changes and the amperes are 1 and 0.7 (but remains confusion regarding the 150W):

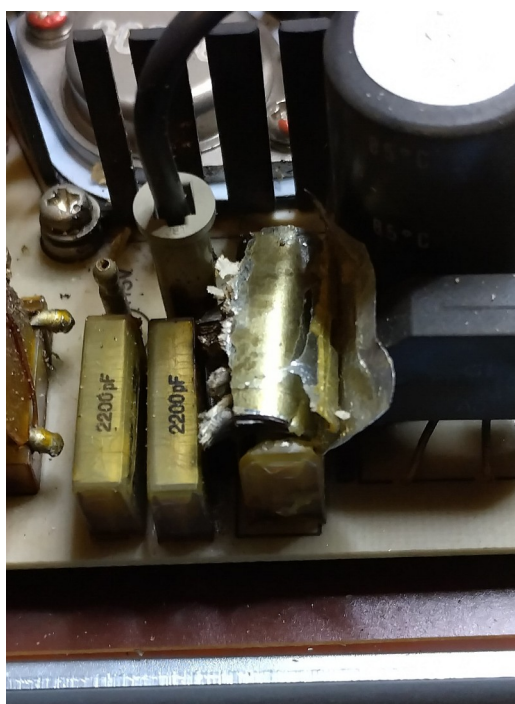
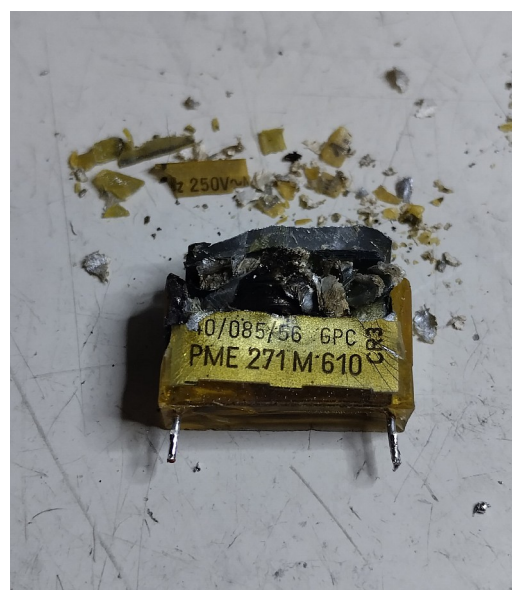
Power supplies usually do not cause major problems, as long as all RIFA filter capacitors are replaced, otherwise they will explode with a smelly smoke that stagnates for hours.

In the photos some examples of exploded RIFAs

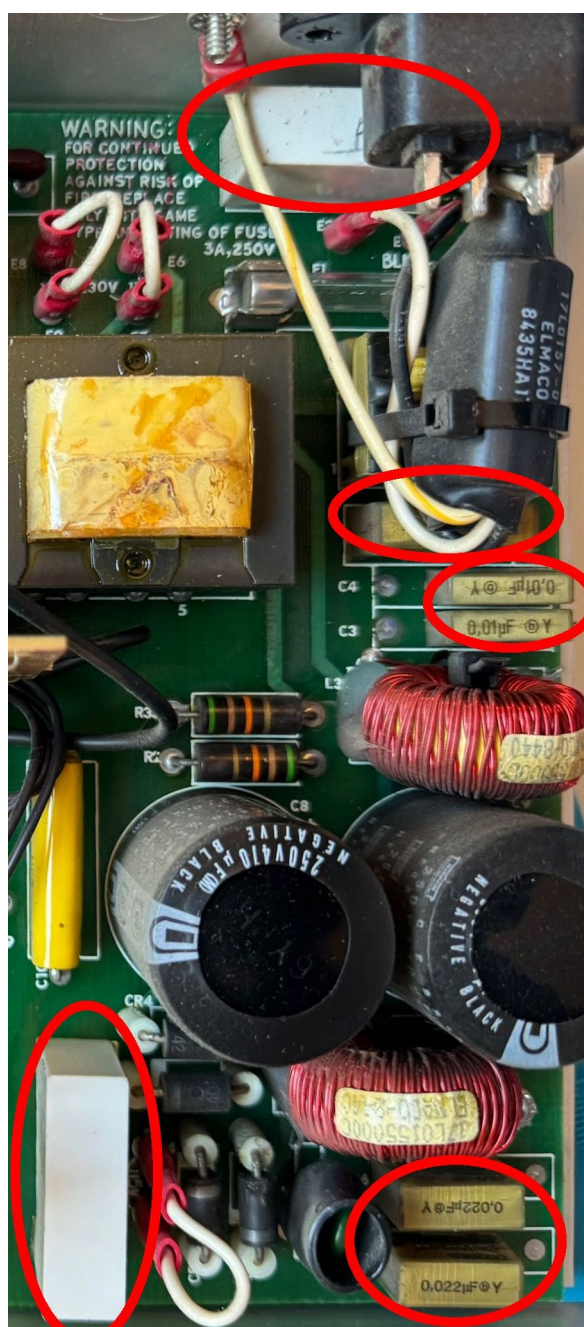
These are to be replaced on the 1.8A power supply, some are a bit hidden and the white ones are already the replacements:

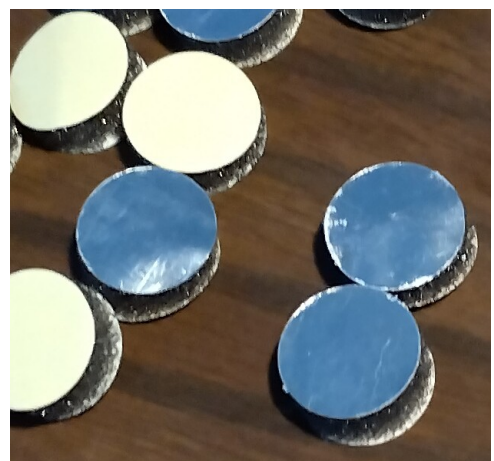
Some enthusiasts have found a way to solve the problem by preparing replacement "buttons", which replace the part of the key that creates the capacitive effect. They are offered for sale on retrocomputing e-commerce sites, but they can be made at home, albeit with a lot of patience as you can find here:

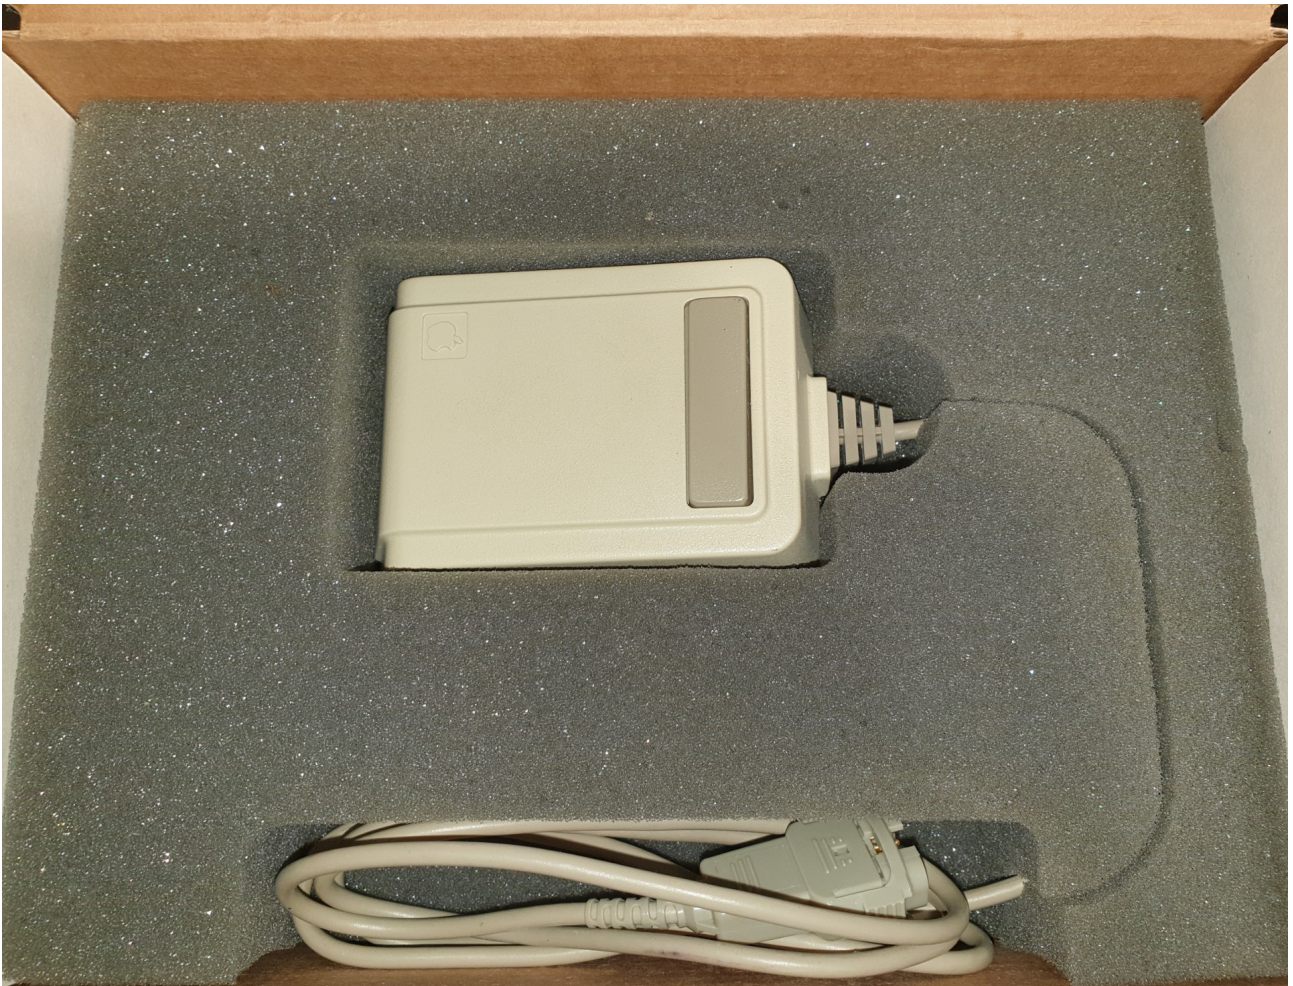
The "thin button" mouse typical of the first Lisas now it's almost impossible to find, especially if in its original box:

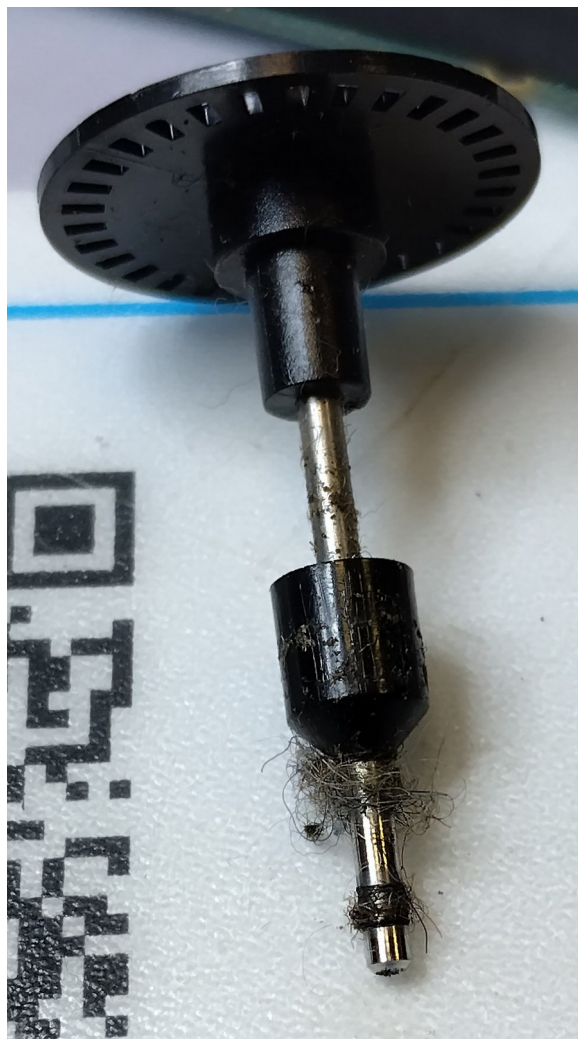
Of course, a good cleaning was enough...
